Camera Site Report

An analysis of the fixed and mobile camera sites in the Thames Valley region

Thames Valley Safer Roads Partnership

October 2009

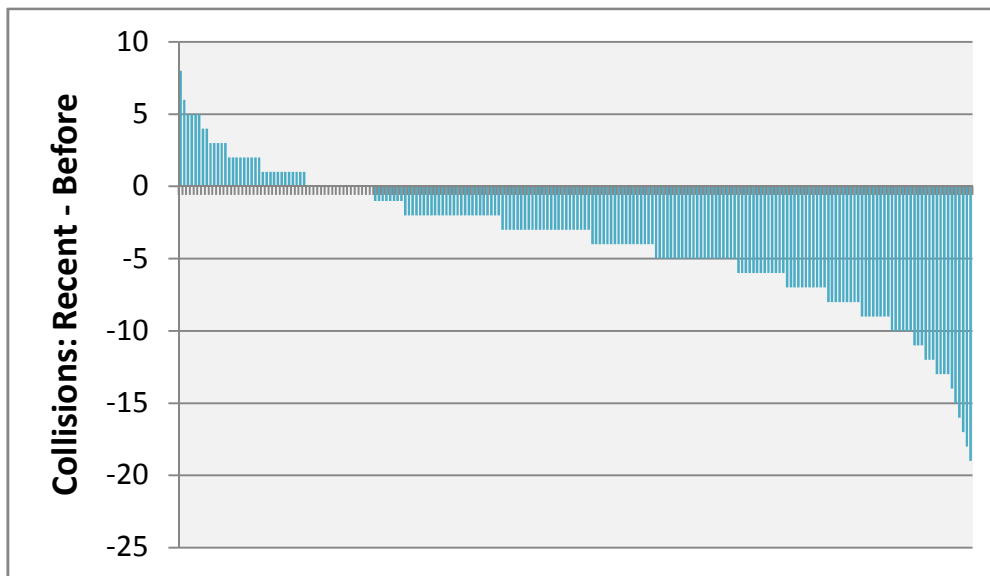
Figure 1 then charts each site across Thames Valley ranked by the collision change. The 34 sites where collisions have increased have typically changed by 1-5 collisions. The 160 sites with a reduced collision level have dropped by typically 1-15 collisions.

Fig 1 - PIC Collisions by camera site: ranked by collision change

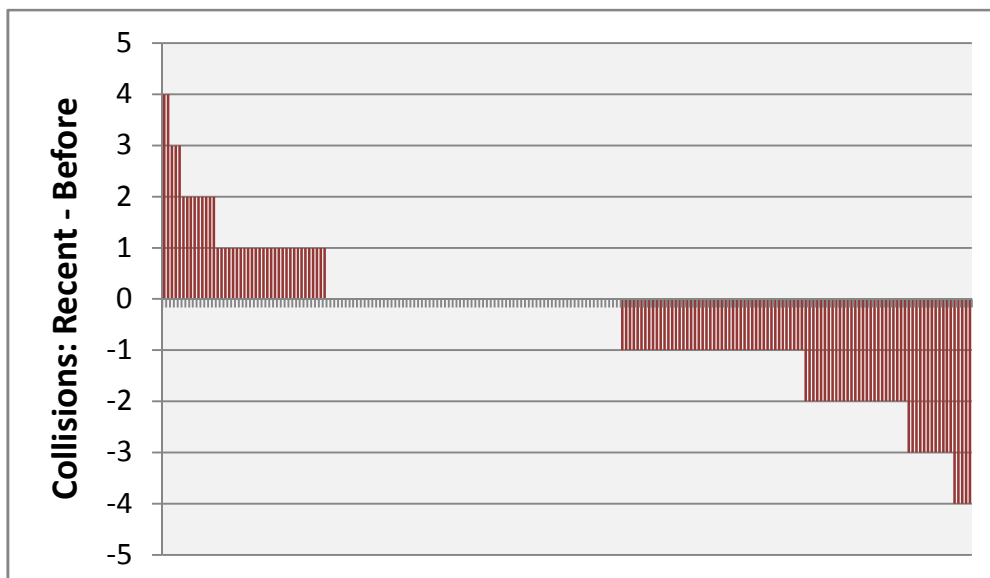
Figure 2 charts KSI changes at the 212 sites, and shows 43 increasing, and 92 decreasing.

Fig 2 - KSI Collisions by camera site: ranked by collision change

Note: "Serious" severity description was changed in 1999. Using the current description, the KSI change (Recent-Before) is probably under-reported by 17%.

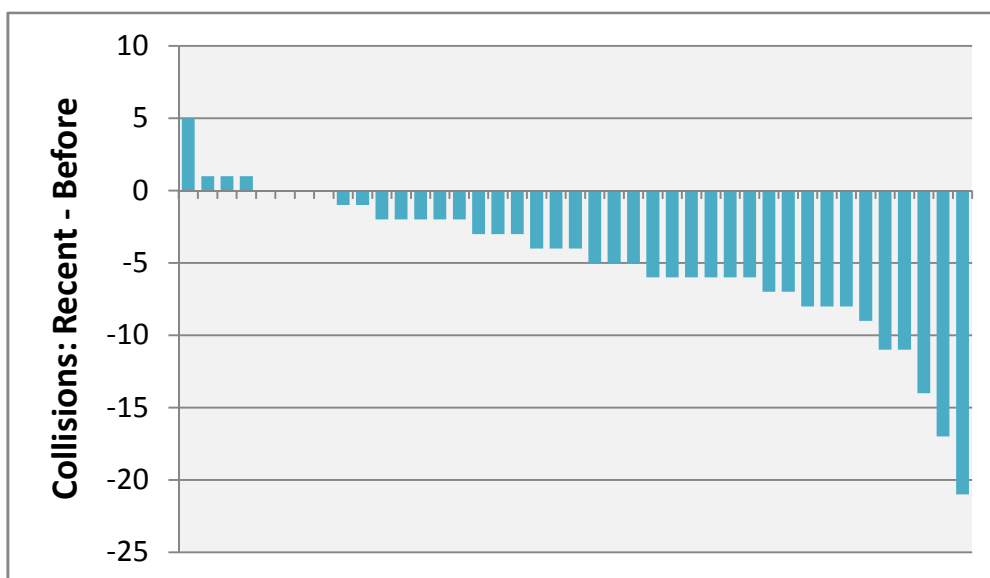
Figures 3 and 4 chart the individual site changes ranked in order of collision change. Only 1 core mobile site has seen an increase in KSI collisions, and that change was +1.

Fig 3 - PIC Collisions by camera site: ranked by collision change

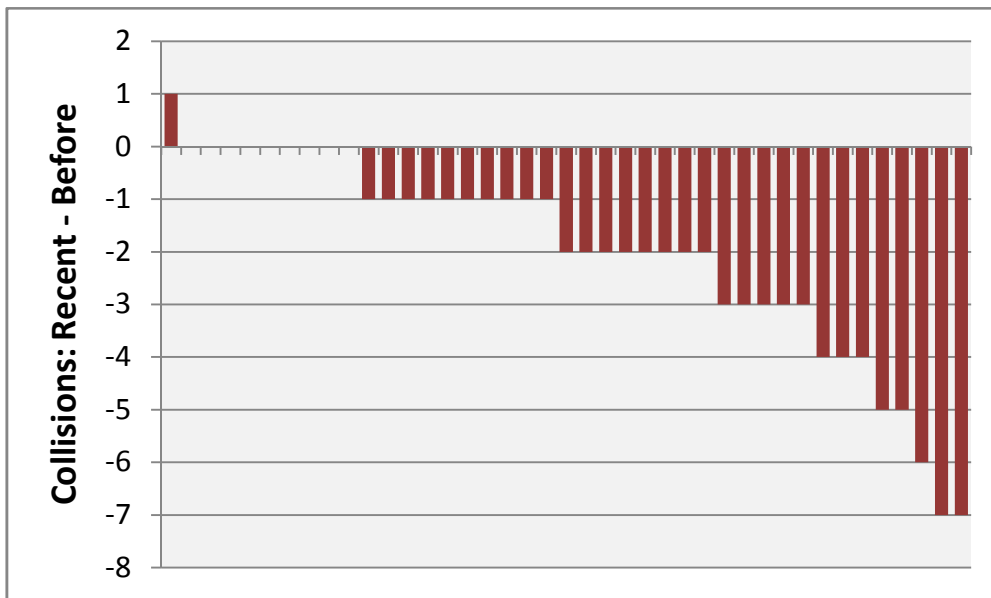
Fig 4 - KSI Collisions by camera site: ranked by collision change

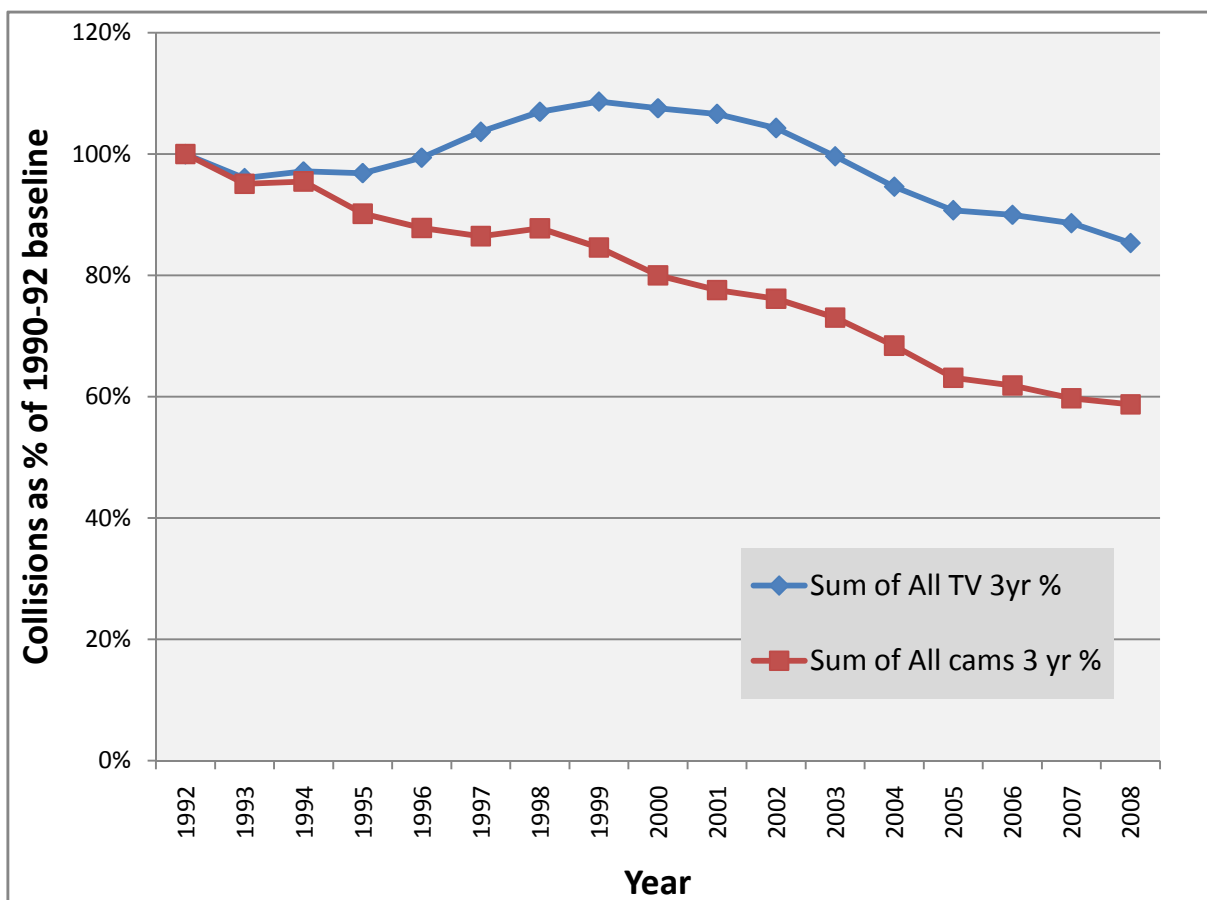
Figure 5:

The average of the 1990-1992 collision figures was used as the 100% baseline for the Thames Valley collisions. All other collision figures were then compared with this as percentages. A rolling three year average was used for each data point. Thus, 1992 represents the average of 1990-1992. Then 1993 is the average of 1991-93, continuing to 2008 which is the average of 2006-2008. Collisions in Thames Valley generally increased to the year 2000 and then showed a drop to around 85% of the 1990-92 baseline by 2008.

Fixed cameras installed in the period 1994 to 1998 were then compared. Again, the period 1990-1992 was used as the baseline, and rolling three year averages were used for each year's total. In percentage terms, the fixed camera trend **matches the Thames Valley trend for the initial 5 year period from 1990 to 1994**. The camera site figures then decrease each year reaching 60% of the baseline by 2008. The difference between all Thames Valley collisions and the fixed cameras sites is shown in Figure 5.

They shows that prior to fixed cameras rolling out pre-1994, collision trends were the same throughout Thames Valley and at fixed camera sites (Figure 5). It has previously been alleged that the reason collisions reduce at camera sites is because they demonstrated unusually high collision rates in the period immediately before installation. This chart clearly demonstrates that trends were the same for at least a five year period.

Figure 5 also demonstrates that collisions rates continue to decrease long after the cameras were installed and that the difference in collision rates compared to the overall Thames Valley figures is maintained. If the drop in collision rates immediately after installation was a blip then you would expect rates to climb again in the long term.
